Recall Campaign 03V-197: Brake Line Clearance

E53 X5

Recall Campaign No. 03V-197: Front Brake Line

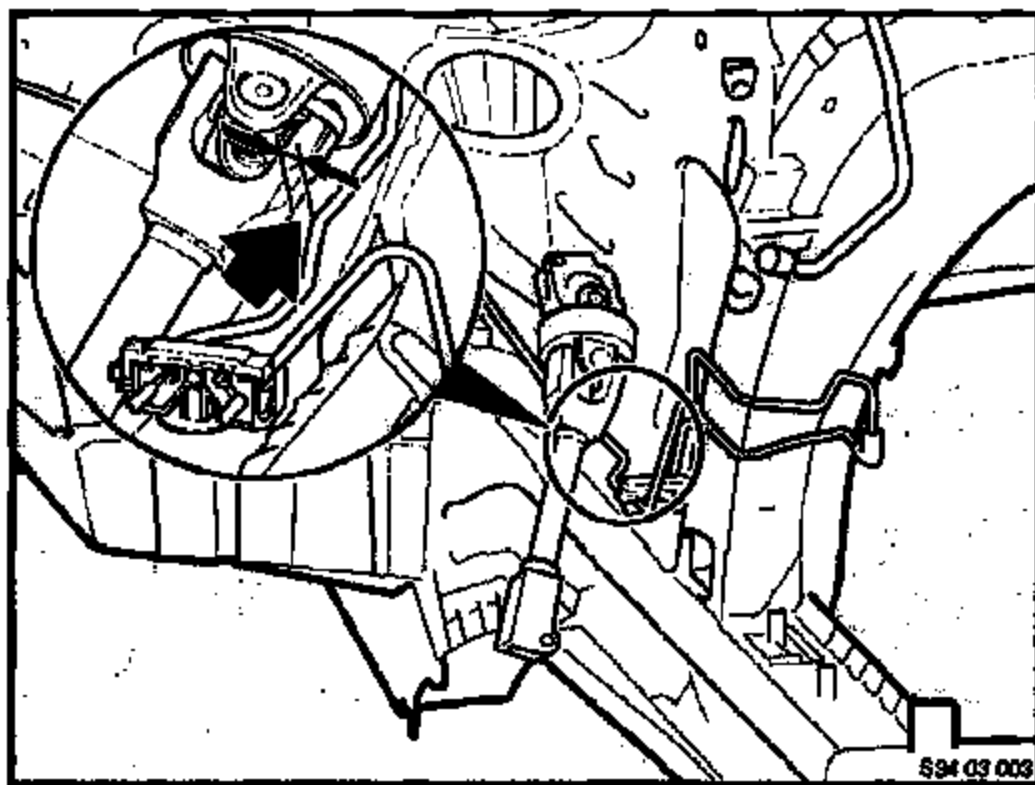
The potential defect involves the clearance between the universal joint of the steering shaft and the brake line. In very rare occasions, it is possible that the universal joint of the steering shaft may come in contact with the brake line. Consequently, the brake line would be subject to damage and corrosion at the contact point.

Using a 5 mm drill bit, check the clearance between the steering shaft and brake line at the point indicated by the large black arrow in the illustration shown below. (Note: only the affected components are shown in the illustration.) If the gap is greater than 5mm, no further action is necessary. If the gap is less than 5mm, the brake line must be repositioned.

Use special tool 11 5 050 or a suitable lever to adjust the brake line clearance. The special tool should be used as a lever with the rubber handle in contact with the brake line and the steering shaft as the support point. Special care should be taken to ensure that the anti-corrosion coating of the brake line is not damaged.
